FAYETTE OLD CITY LAKE DAM HOWARD COUNTY, MISSOURI MO 10131

PHASE 1 INSPECTION REPORT NATIONAL DAM SAFETY PROGRAM

PREPARED BY: HOSKINS-WESTERN-SONDEREGGER, INC.

SEPTEMBER, 1978

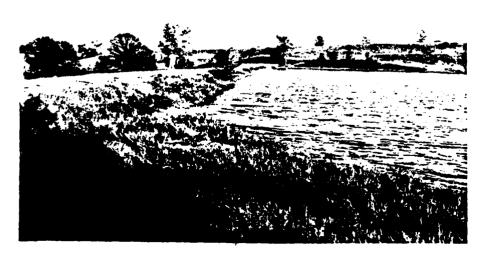
PHOTO. NO. 10 UPSTREAM SLOPE OF DAM FROM LEFT END OF DAM.

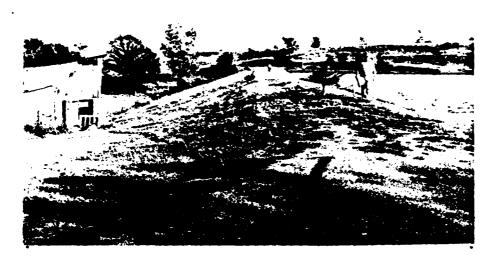
A few rodent holes were observed on the downstream slope. No slides or abnormal deformations were noted on the embankment.

PHOTO. NO. 11 DOWNSTREAM SLOPE FROM LEFT END OF DAM. APPENDIX C PLAN, PROFILES & SECTION
